# FLOOD PLAIN MANAGEMENT STUDY **COPPER RIVER COMMUNITIES**

# **FLOOD PLAIN MANAGEMENT STUDY**

## **COPPER RIVER COMMUNITIES**

Includes Gakona, Gulkana, Copperville Subdivision,  
Tazlina, Silver Springs Subdivision, Copper Center,  
Tonsina, and Lower Tonsina

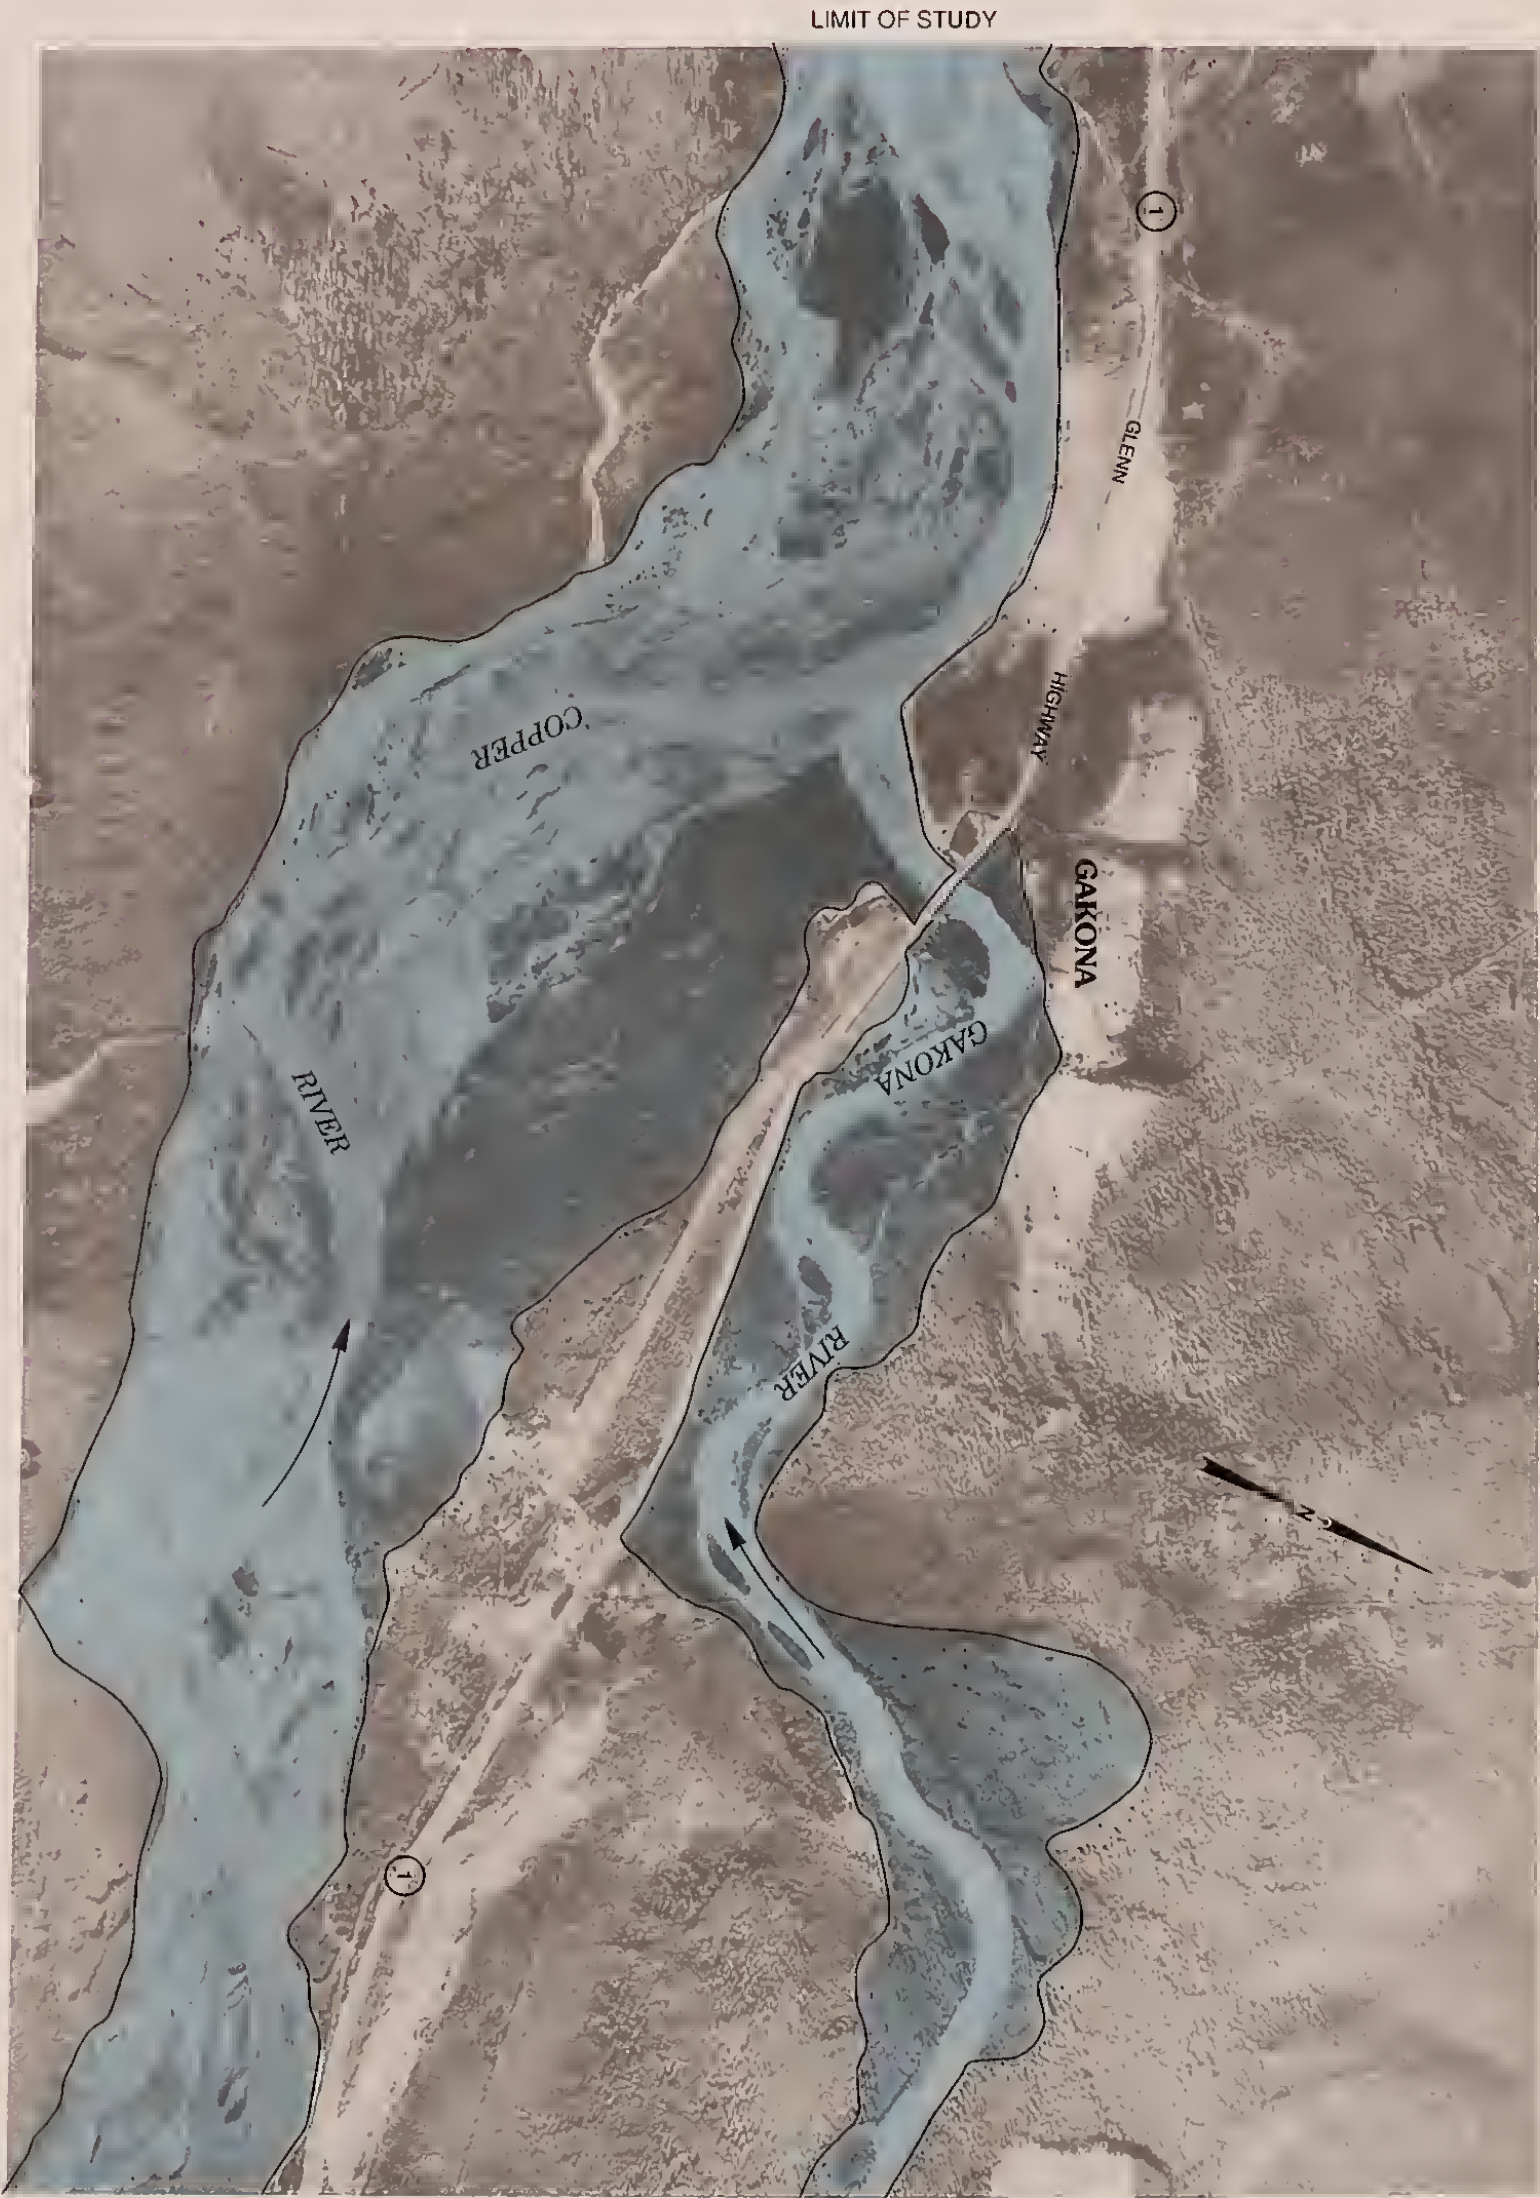
FLOOD HAZARD AREA

The boundary shown on the flood plain management maps was approximated using soils and vegetation mapping, geomorphic surfaces, and the historical record. It should be considered a minimum estimate. As the flood boundaries shown are estimates and the actual limits of overflow may vary somewhat from those shown on the maps because the scale of the maps does not permit precise plotting of the flooded area boundaries, it is recommended that a "freeboard allowance" of at least two feet above shown boundaries be provided for any new development or mitigation measure.
